Note: The Rescue Sheet depicts a LHD vehicle (as allowed under the ISO 17840-1). All components (other than steering wheel and passenger airbag) are located in the same position in the Aust/NZ RHD model.

Always wear appropriate high voltage and turn-out PPE when addressing a damaged Chrysler Pacifica Hybrid PHEV.

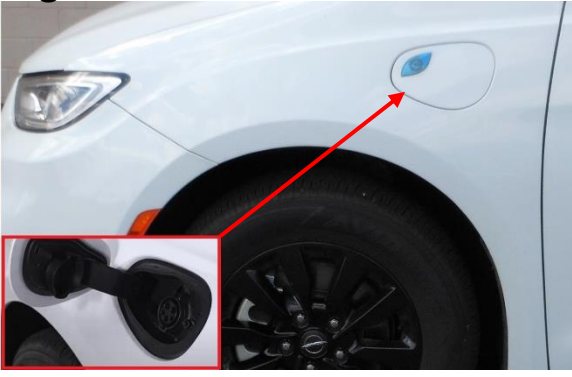
Charging port door with “e” leaf logo on left side:

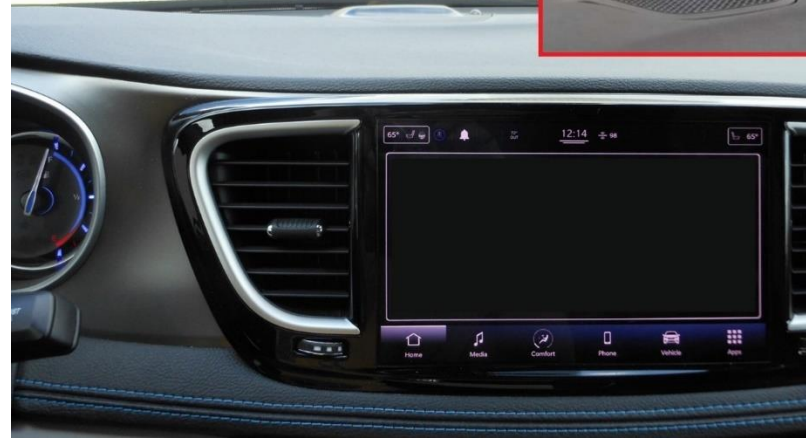
Charge status indicator on top of dash:
Only illuminated when plugged in and charging.

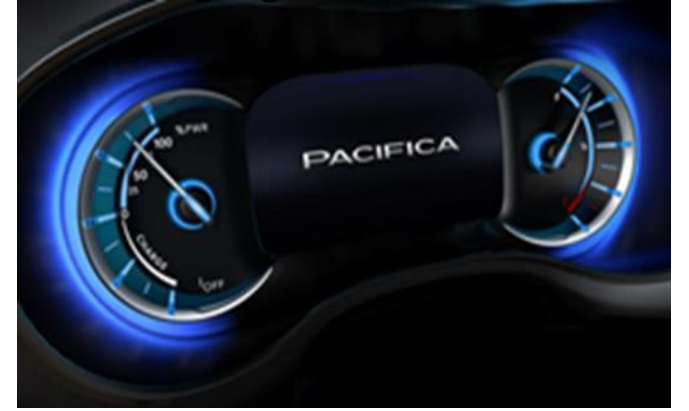
Left dash gauge is a power meter:

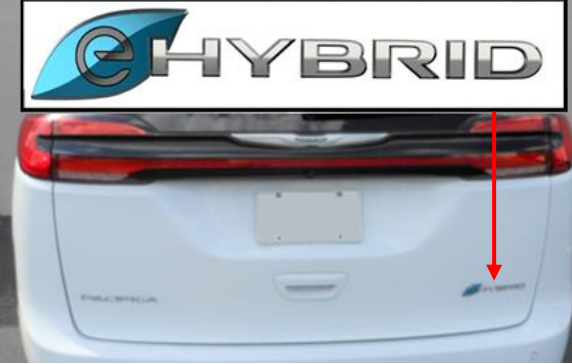
Badge rear lift gate right corner:

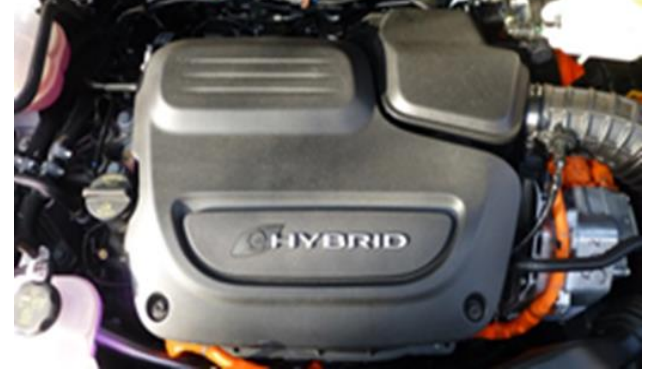
Unique engine cover:

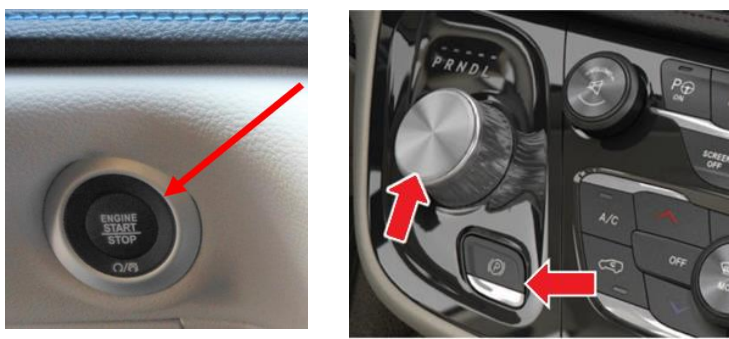
1. Set ignition to “RUN” or “ACC”
2. Place Shifter in Park (rotate counterclockwise)
3. Set Parking Brake by pulling up on switch

Note: 12V power must be activated to shift in and out of PARK or to change the PARKING BRAKE state.

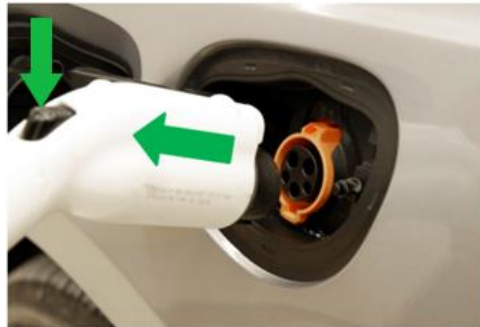
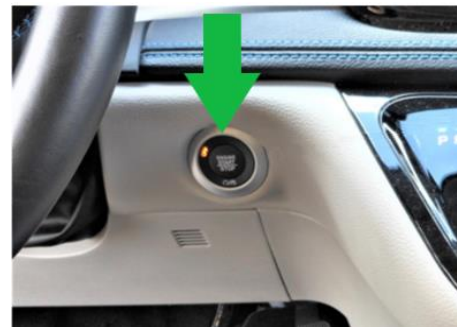
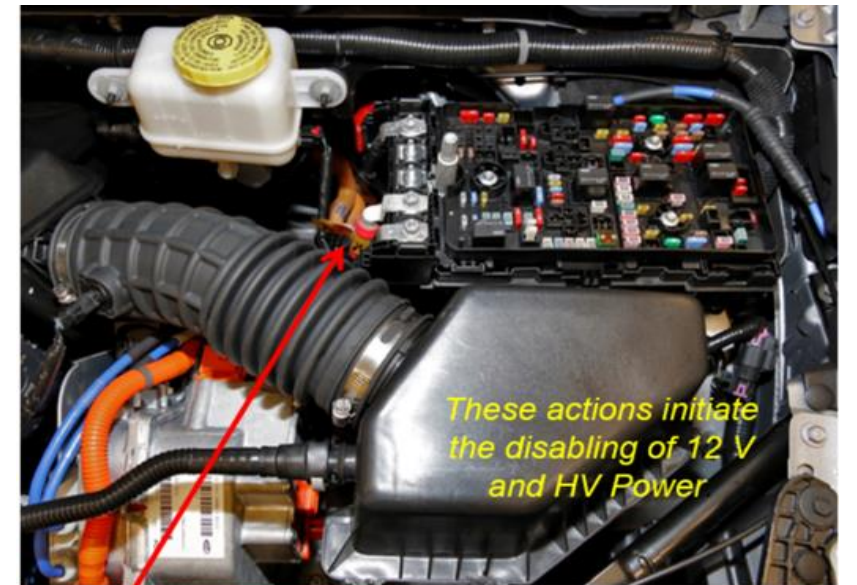
1. Unplug from any charging equipment
2. Set Ignition to OFF
3. Move key fob at least 6 meters (20 feet away)
4. Open hood
5. Cut a segment of cable away at the responder cut tape

First Responders Label as seen in vehicle

This disables high voltage and some low voltage **including restraints**

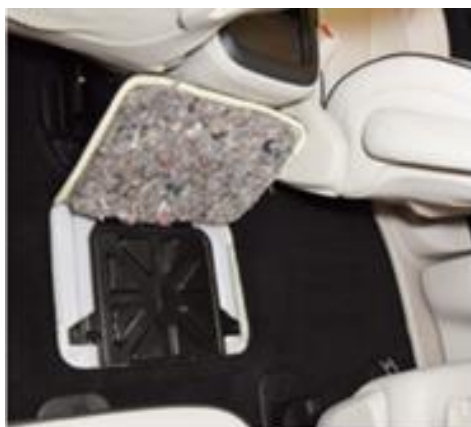
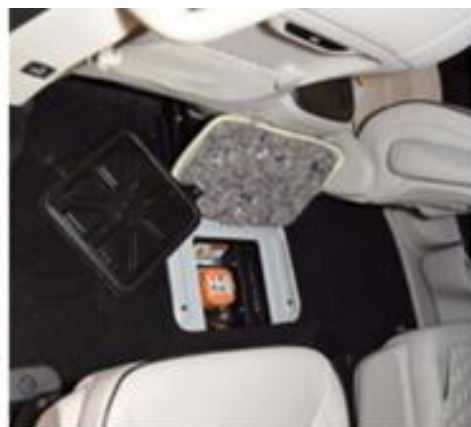
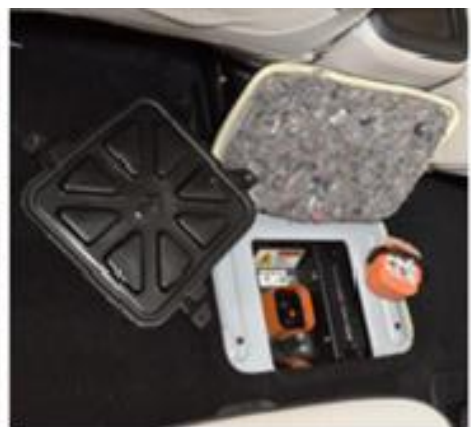
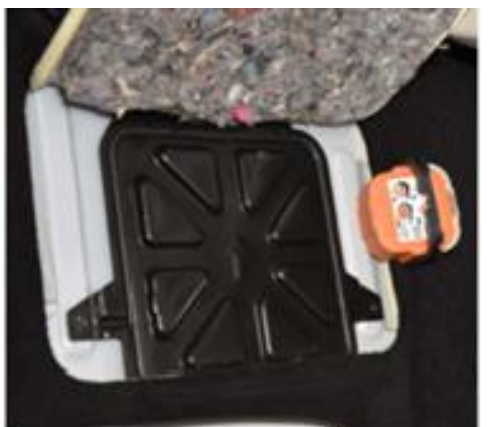
The Service Disconnect cover is located between the 1st and 2nd row seats.

1. Uncover Service Disconnect access cover
2. Unbolt the cover panel
3. Remove the Service Disconnect
4. Reinstall the cover over the empty socket

This method disables high voltage, but **NOT LOW VOLTAGE**—**restraint systems will remain powered.**

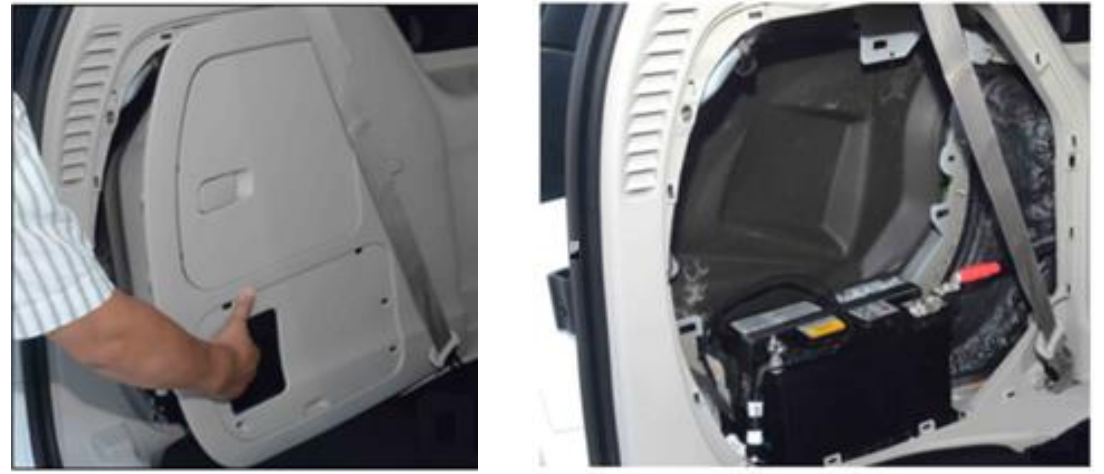
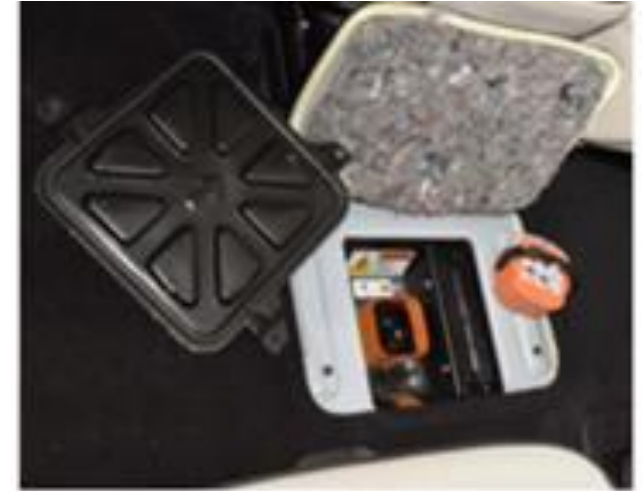
Inverted vehicle power-down procedure- Perform if vehicle is inverted or hood access is blocked:

1. Access passenger compartment through rear lift gate, lift gate window or side door if possible.
2. Locate the 12 volt battery access on the driver's side adjacent to the lift gate in rear of vehicle.
3. Open battery terminal access door.
4. Grab trim assembly firmly through terminal access opening (including upper compartment).
5. Pull outward to dislodge retaining clips.
6. Remove trim assembly to expose battery.
7. Cut away or remove all negative battery cables.
8. Locate Service Disconnect floor well behind and between the front two seats and uncover.
9. Unbolt the inner service disconnect cover.
10. Remove the service disconnect.
11. Replace the cover to protect against water and debris
12. Wait 5 minutes.

This will disable power to high and low voltage systems. However, under some circumstances the HV Battery System Contactors may not open. In such instance, either or both systems could remain energized.

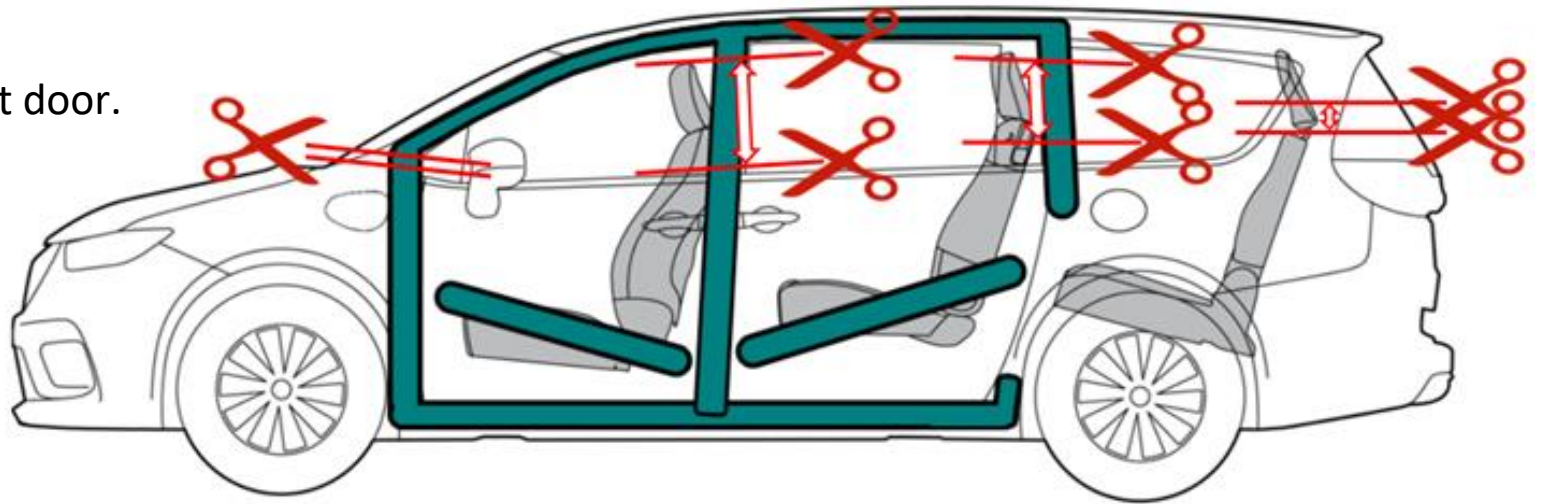
Recommended cut points:

Laminated Glass: Windshield and front door.

Tempered Glass: Front and rear quarter glass, rear door, lift gate and sunroofs.

Do not cut into restraint system (belts only may be cut with a knife).

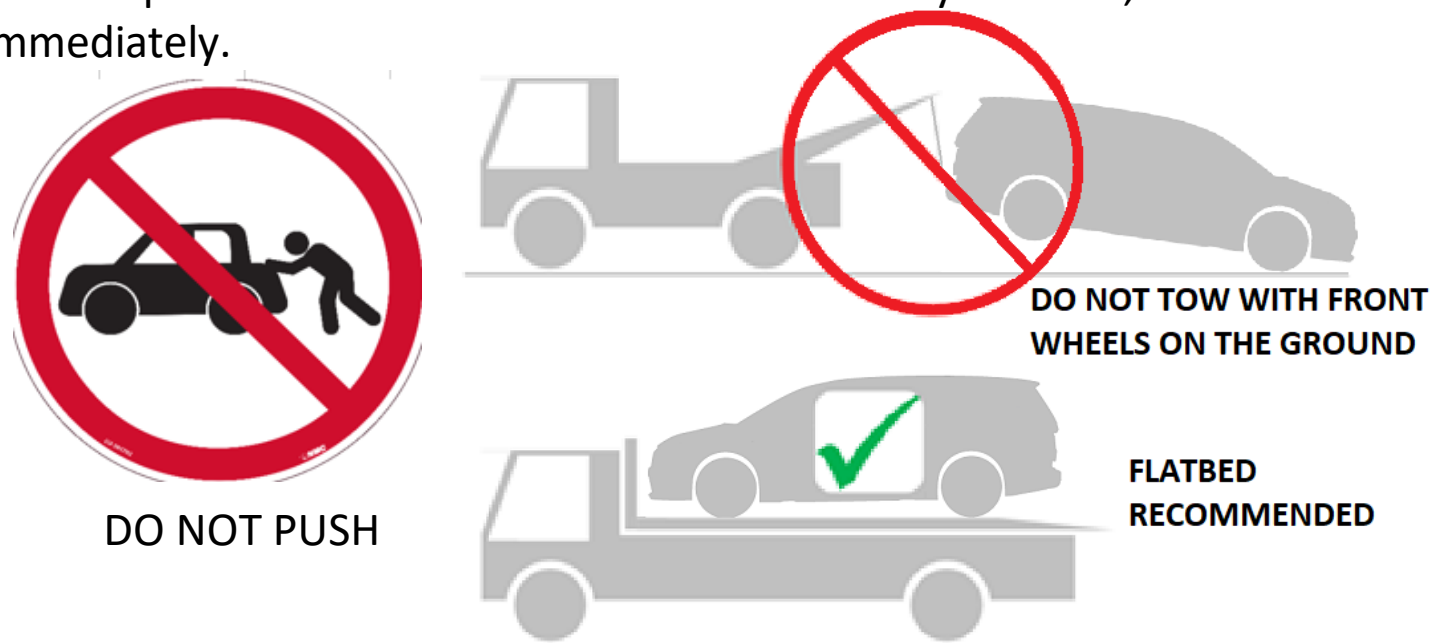
Towing Instructions:

1. Place car in PARK, with brake on
2. Transport on flatbed or trailer ONLY
3. Drag vehicle onto flatbed or trailer
4. Secure fully to conveyance
5. At location, drag off conveyance
6. Leave vehicle in PARK with brake set
7. Chock wheels if not secured otherwise
